# DEAN Scene

Customer Newsletter

March 2015

## Better Buildings, Inc. Completes North Trail RV Project in Fort Myers

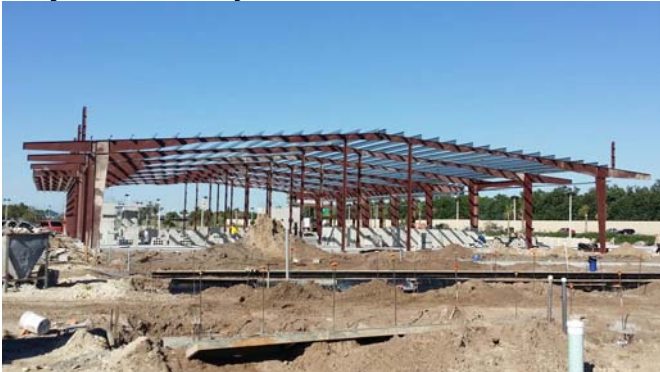
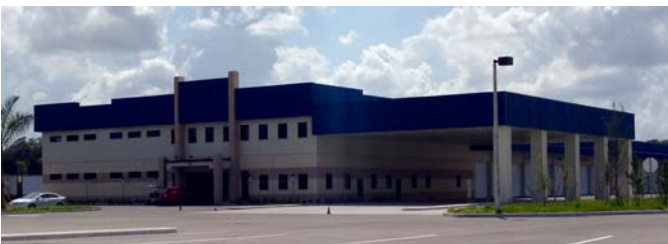
**North Trail R.V. Project**

The building consists of a 47,000 sq. ft. maintenance building with 12' tapered beam canopies down both side walls. Among the many special features of the building are a 6,000 sq. ft. service drive through a fully sheeted dropped ceiling, a 12,000 sq. ft. office/parts building with 32' eave height and full mezzanine.

The entire building is wrapped with a 26' to 36' fascia and parapet system. The roof panels of the office building are 24G Prolok; the roof of the maintenance building is made from 26G material.

All wall panels are 26G Rib Twelve with a Kynar finish. The fascia and parapet panels are 26G Rib Six.

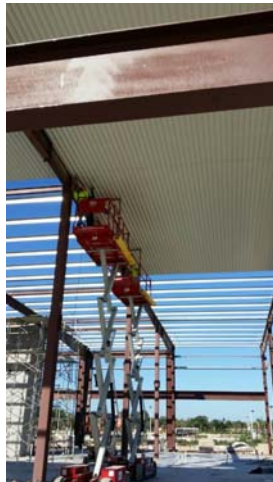
One of the most common wet jobsite problems is white and black corrosion in bundles of roof and wall panels. When galvanized or alumina-zinc panels are stacked and are exposed to moisture and deprived of oxygen, storage staining can occur. Once the corrosion occurs, it is very difficult to remove, so the best defense is a good offense.

Color coated panels are not immune from corrosion that starts underneath coated surface and first appears in the form of blisters on the surface. Eventually, the corrosion will cause the coating to delaminate from the substrate.

At the jobsite, identification of wet staining should be done quickly. Typically, there is no defined orientation to the staining pattern and the first instinct may be a coating lamination complaint. If the panels are still stacked in the bundle, a wet stain pattern could be a mirror image on the bottom side of the panel to the top side of the panel that it was in contact with to help distinguish it from a finish defect.

To prevent storage stains, it is recommended to store bundles of panels under cover until use if possible, allow air circulation around the bundle, slope and cover the bundle, and re-cover partially used bundles. More information on on-site storage can be found on the back of the cover of the [Standard Construction Details Booklet](#).
